SOURCE: Compaq Computer Corporation INFORMATION BLITZ

Incorrect connection of fans in DWLPB-CX can destroy them.

INFORMATION BLITZ #: TD 2611-CR

PRODUCT NAME(S) IMPACTED: AS8200, AS8400RM, GS60, and GS30E

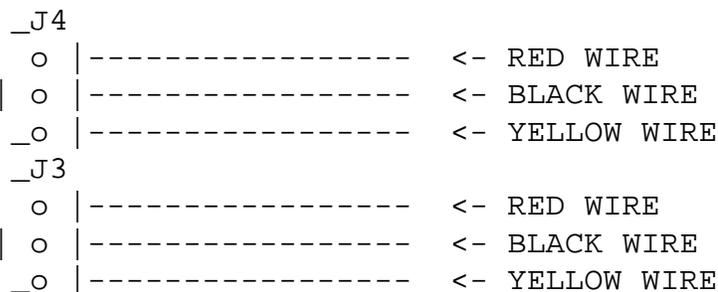
Diagram 1.

While servicing the DWLPB option, it is possible to INCORRECTLY insert the 3-pin fan connector to the power daughtercard far enough to apply +48volts to the fault signal connector. The fault circuitry in the fan can not withstand this voltage even momentarily. This usually results in a fan that gives a constant fault signal, which turns off the 'Power OK', LED. In some cases, it may never signal a fan failure. This could result in permanent damage to the PCIA motherboard. In some cases, the damage may exhibit itself only intermittently

Both fans spin but 'Power OK' LED does not light or stopping a fan manually does NOT extinguish 'Power OK' LED. Some unexplained system hangs may be attributed to intermittent false fault signal.

When connecting the fans to the daughtercard, ensure that the wires come off the connector AWAY from the grillwork through which they are fed and the RED wire is to the closest edge (See diagram 1). If the symptoms appear or you suspect that a fan had been previously plugged in incorrectly; replace fan (12-23609-19) immediately.

Make sure new fan has date-code 960710 or higher.
