Brocade Fabric OS v5.0.5d

Release Notes v1.0

May 18, 2007

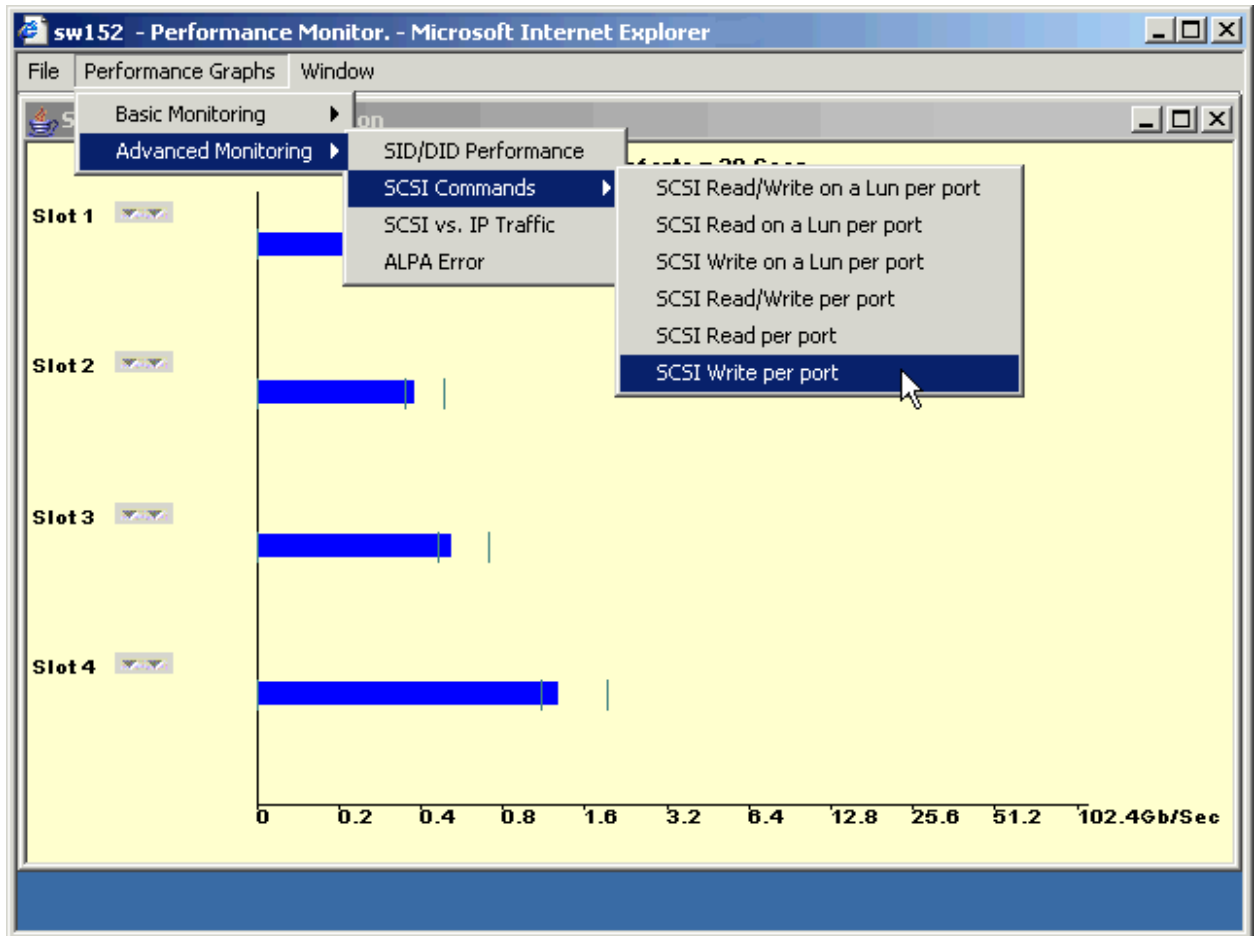
Figure 14-1 Accessing Performance Graphs

Port throughput utilization is represented by a horizontal bar for each selected port, which gets longer or shorter depending on the percent utilization for that port at the last poll time. Thin short vertical intersecting bars give a historical perspective by representing the highest and lowest values reached for each selected port since the graph was opened. A third bar between them represents the average of all values polled. (See Figure 14-1.)

On page 14-3, replace Figure 14-1 with this one:
