RELEASE NOTE

6.57 Open AT[®] FW

6.57 Open AT[®] FW Release Note

Reference: **WM_DEV_OAT_DVD_163**

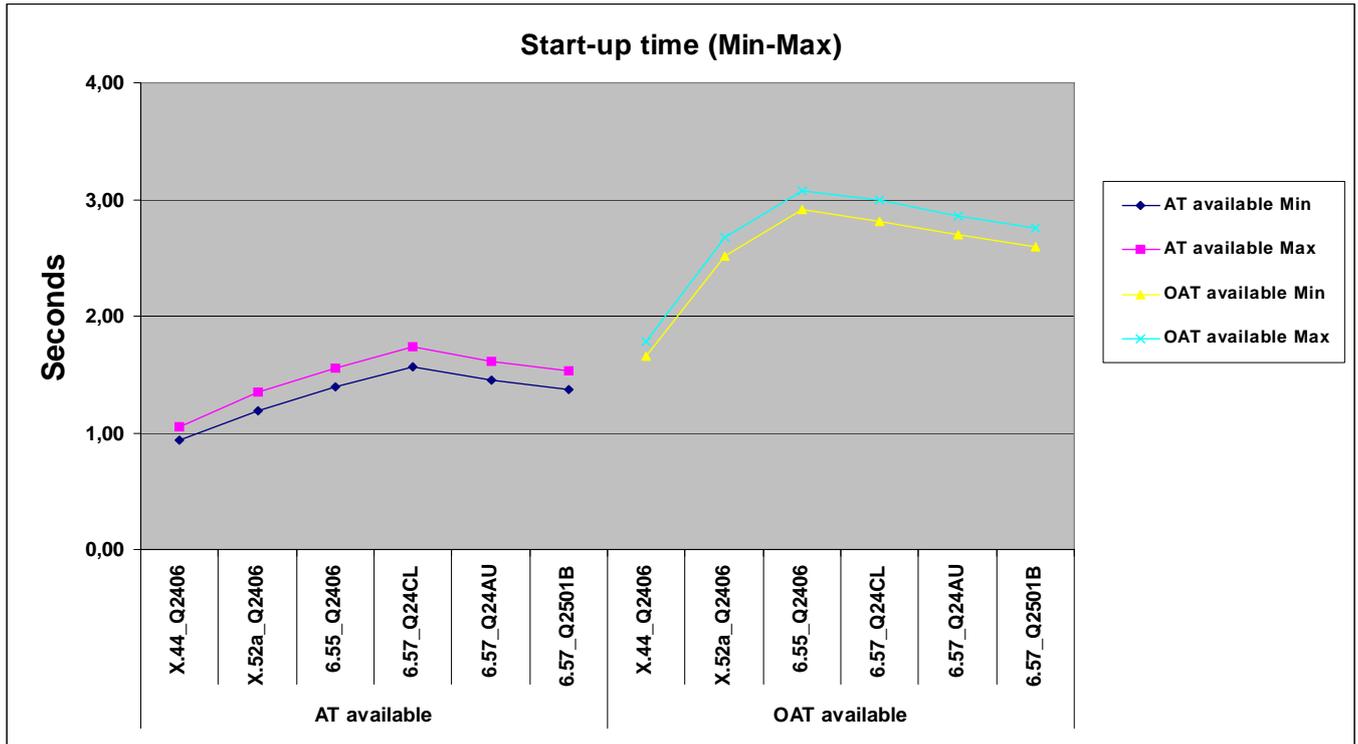
6.4.1 Start-up Time

6.4.1.1 AT available start-up time

AT available start-up time is the time elapsed between a hardware reset and unsolicited AT response +WIND: 3 on terminal sent by the wireless CPU. The whole set of AT commands included in the wireless CPU is not available at this moment, all commands relative to SIM are still locked until SIM init complete (+WIND: 4).
